UNDERWATER BRIDGE INSPECTION REPORT

STRUCTURE NO. 5270

RED RIVER OF THE NORTH

DISTRICT 4 - CLAY COUNTY, CITY OF MOORHEAD

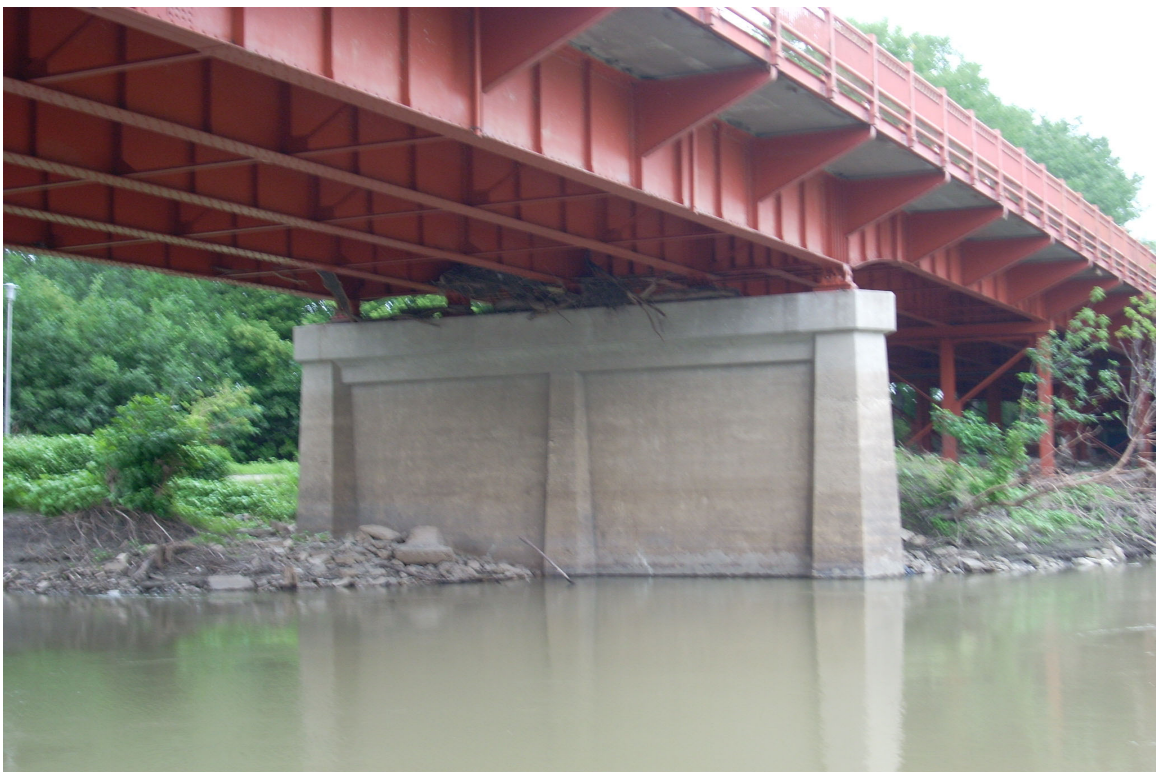
- (B) A moderate accumulation of timber debris with drift pieces up to 6 inches in diameter was observed along the downstream half of the east face of Pier 6, the debris extended from the channel bottom up 3 feet and off the pier faces by up to 6 feet.

- (D) An area of section loss, 2 feet wide by 18 inches high with 2 inches of penetration was located at the waterline at the downstream nose of Pier 6 with exposed reinforcing steel exhibiting less than 10 percent section loss.

Photograph 2. View of Pier 6 and West shore, Looking West.

- (A) Monitor the channel bottom elevations especially around the exposed Pier 7 footing after major flood events and during the biennial inspections.
- (B) Remove the accumulations of timber debris at Piers 6 and 7 during future maintenance operations.
- (C) Reinspect the submerged substructure units at the normal maximum recommended (NBIS) interval of five (5) years. If soundings during or after a high water event suggest the presence of scour and increased footing exposure, and underwater inspection may be warranted at that time.

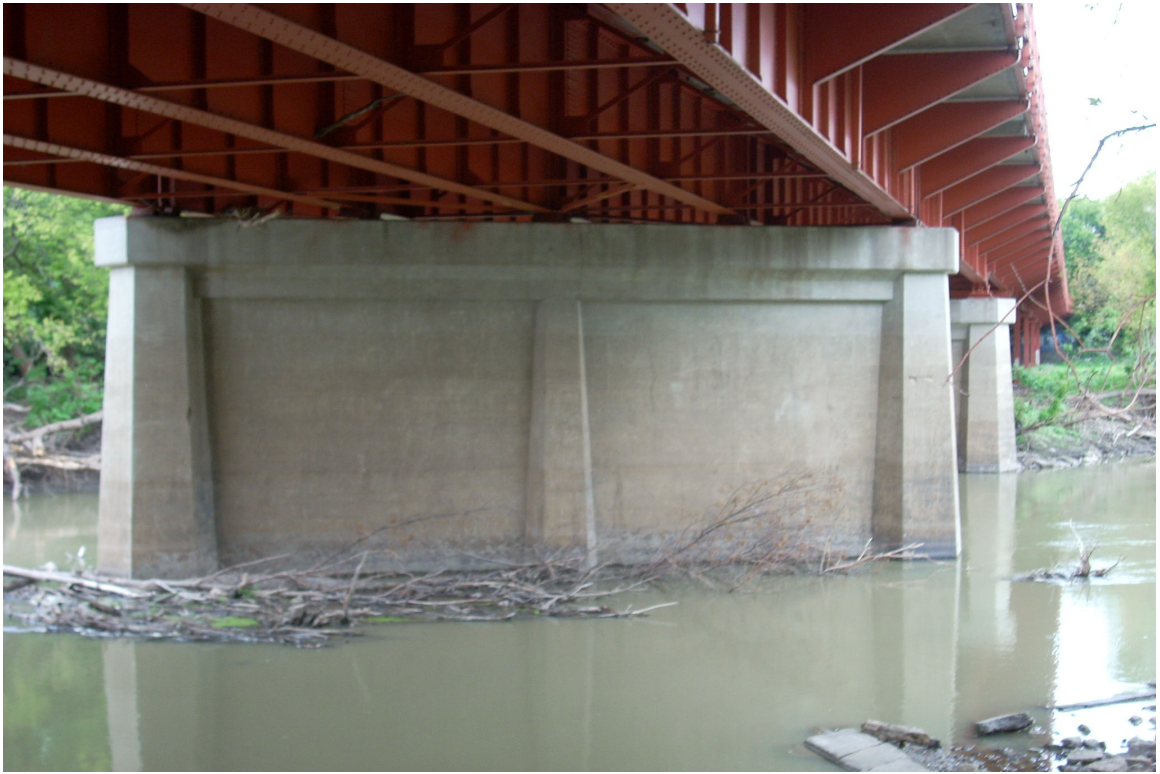
- (C) A heavy accumulation of timber debris, consisting of logs and branches up to 2 feet in diameter, was observed around the entire perimeter of Pier 7. The debris extended from the channel bottom to 1 foot above the waterline.

- (F) The footing of Pier 7 was exposed along the entire west face of the upstream column with up to 2 feet of vertical face exposure.

Photograph 3. View of Pier 7, Looking West.

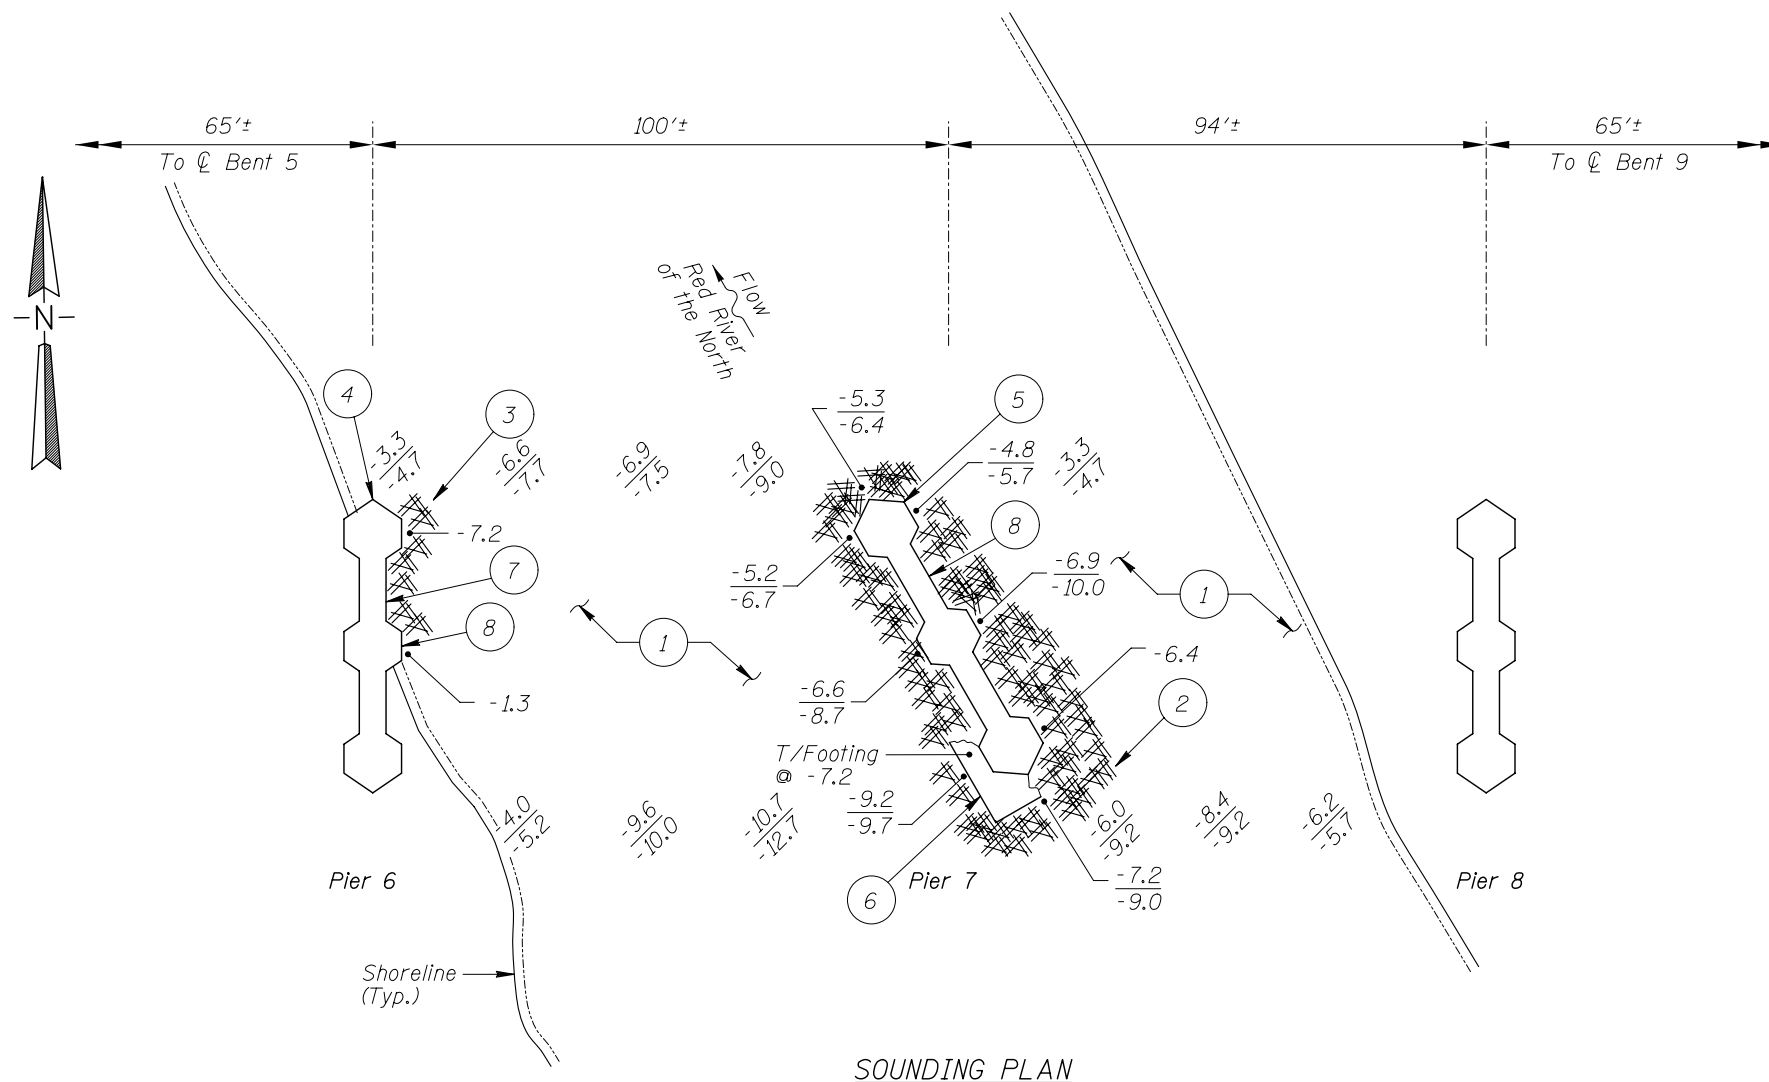
INSPECTION AND SOUNDING PLAN

- The channel bottom material around the entire perimeter of Piers 6 and 7 consisted of cobbles, rocks, and concrete rubble up to 2 feet in diameter.
- A heavy accumulation of timber debris, with pieces up to 2-feet-diameter, was observed around the entire perimeter of Pier 7. The debris extended from the channel bottom to 1 foot above the waterline and up to 20 feet off the east face, 10 feet off the west face and downstream nose, and 15 feet off the upstream nose.

- A moderate accumulation of timber debris, with pieces up to 6-inch-diameter, was observed along the downstream half of the east face of Pier 6. The debris extended from the channel bottom up 3 feet and off the face up to 6 feet.

- An area of section loss 2 feet wide by 18 inches high with 2 inches of penetration was located at the waterline at the downstream nose of Pier 6 with exposed reinforcing steel exhibiting less than 10 percent section loss.

- A 1 foot high by 6 inch wide spall with exposed and corroded reinforcing steel was observed at 10 feet above the waterline on the Northeast corner of Pier 7 downstream column.

- Exposed footing, located 7.2 feet below the waterline, with up to 2 feet of vertical face exposure was observed along the entire west face of the upstream column of Pier 7.

- A vertical crack up to 1/4 inch wide was observed in the Pier 6 webwall at 6 feet north of the center column extending from 1 foot below the waterline to top of cap.

- Light to moderate scaling with 1/8 inch typical penetrations and 1/2 inch maximum penetrations was observed from 4 feet above the waterline to the channel bottom on Piers 6 and 7.

Monitor the channel bottom elevations especially around the exposed Pier 7 footing after major flood events and during the biennial inspections.

Remove the accumulations of timber debris at Piers 6 and 7 during future maintenance operations.

Reinspect the submerged substructure units at the normal maximum recommended (NBIS) interval of five (5) years. If soundings during or after a high water event suggest the presence of scour and increased footing exposure, and underwater inspection may be warranted at that time.
